# Lift and Escalator Safety: Key Audit Findings and Case Studies (Oct 23 – Sep 24)

Jody Tan, Senior Engineer

Investigation and Enforcement Department

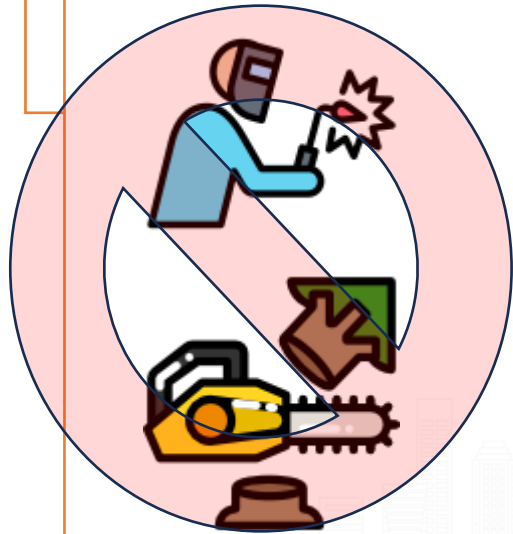
Cutting or welding are not proper ways to replace bearings. These methods can damage the shaft and make it unsafe.

1. Always use proper tools for bearing removal and installation.
2. Do not chisel or hit the shaft with hard objects, as this can cause dents and surface damage to the shaft.
3. No welding repair on the shaft.
4. Before deviating from SOPs, consult with the manufacturer or a certified expert.
5. Regular training, supervision are essential.

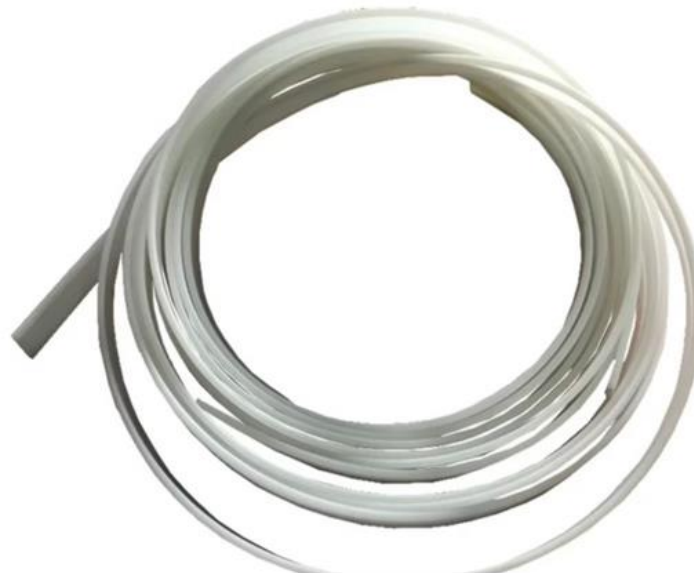
- The handrail guide insert sits between the stationary guide rail and the moving handrail, reducing friction between them. It's clipped to the handrail guide with/ without a holding bracket at one end.
- Due to frequent movement causing wear and tear, the insert may occasionally fall into the escalator system, potentially causing jams or creating sharp edges on the handrail.
